## The Evaluation of Roads Width on Cultural Heritage Area's Street Sections in Bandung City

Ina Revayanti  
Universitas Winaya Mukti

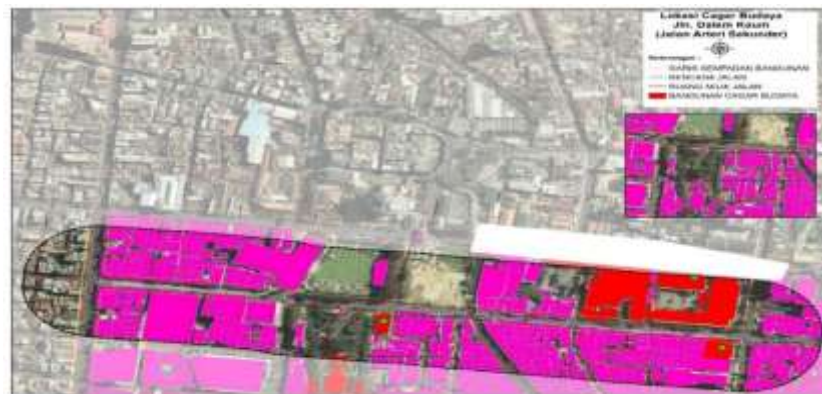
Figure 13. Map of Evaluation of Cultural Heritage Locations Around Jalan Dalem Kaum

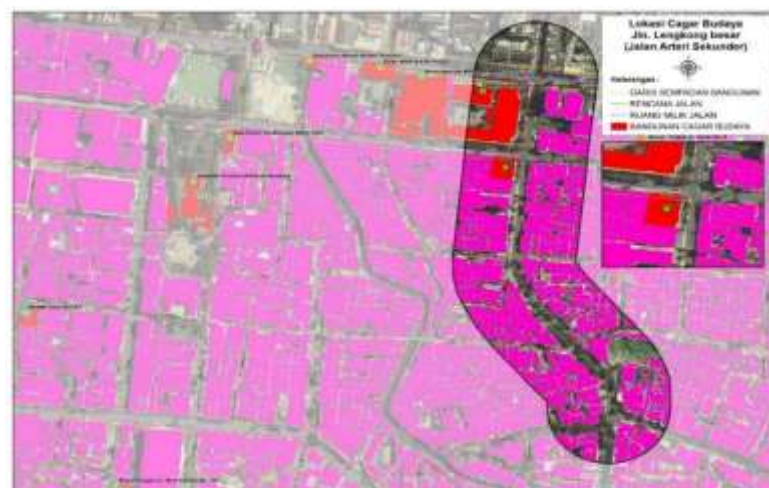
Figure 14. Evaluation Map of Cultural Heritage Locations Around Jalan Lengkung Besar

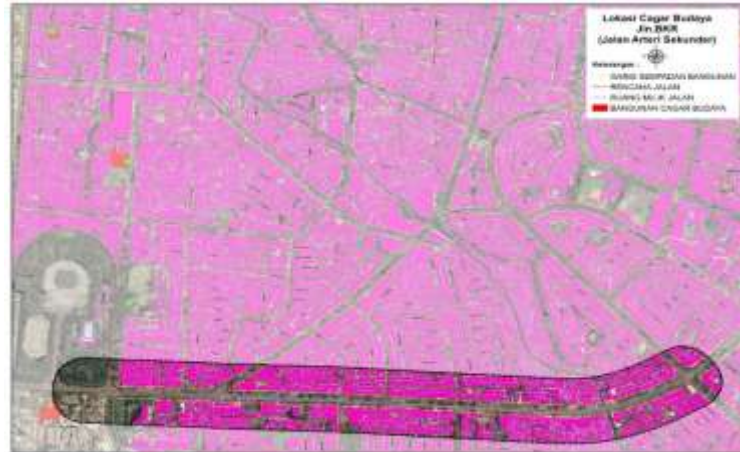
Figure 15. Map of Evaluation of Cultural Heritage Locations Around BKR Street

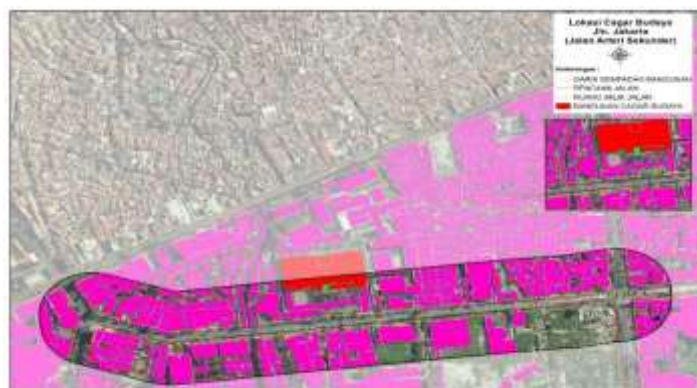
Figure 17. Map of Cultural Heritage Locations Evaluation Around Jakarta Street

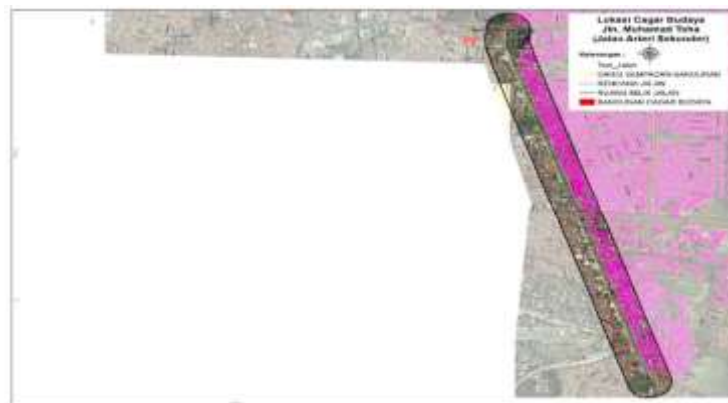
Figure 19. Map of Evaluation of Cultural Heritage Locations Around Jalan Muhammad Toha

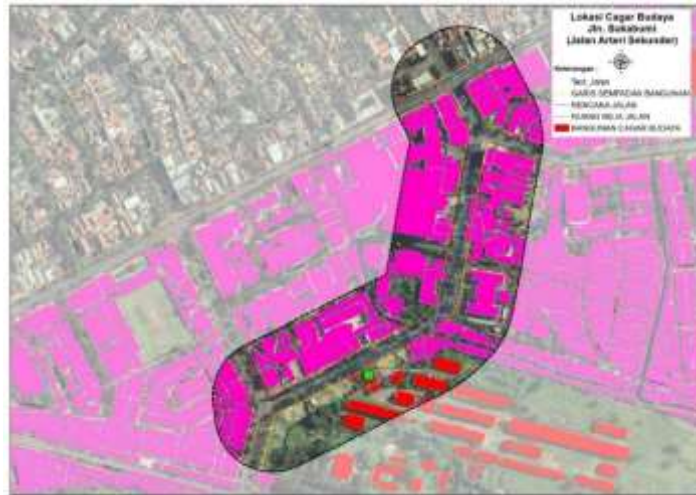
**Figure 21. Map of Evaluation of Cultural Heritage Locations Around Jalan Sukabumi**
